AMD-K6[®]

Processor Revision Guide

Model 7

Publication # 21846 Rev: G Amendment/0 Issue Date: August 1998
--

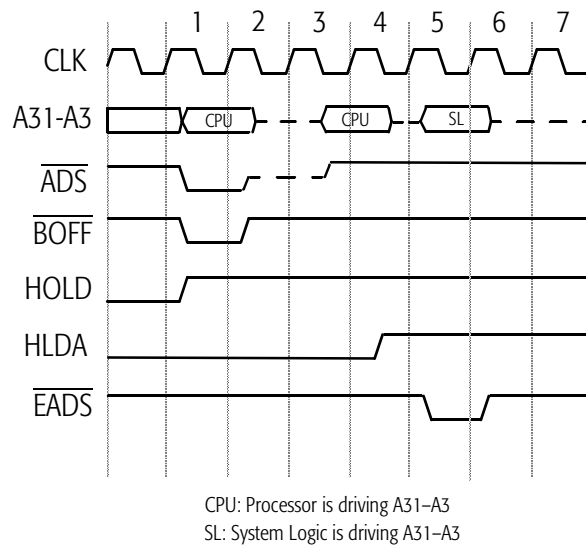
Figure 1. AMD-K6[®] Processor Assertion of HLDA Due to Simultaneous BOFF/HOLD Assertion

2.2.2 HLDA Assertion Delayed by One Clock

Non-conformance. If $\overline{\text{BOFF}}$ and HOLD are sampled asserted on the same clock edge that negates $\overline{\text{ADS}}$, the processor asserts HLDA two clock edges after HOLD is sampled asserted.

Potential Effect on System. There are three potential effects of this erratum to consider:

- If the system logic asserts $\overline{\text{BOFF}}$ for a duration of one clock, anticipates the assertion of HLDA in clock 3 (see Figure 1)—which is the normal specified operation—and drives the address bus and $\overline{\text{EADS}}$ for an inquire cycle in clock 3, then the processor will not sample $\overline{\text{EADS}}$ asserted. In addition, address bus contention will occur in clock 3.

- If the system logic asserts $\overline{\text{BOFF}}$ for a duration of two clocks, anticipates the assertion of HLDA in clock 3, and drives the address bus and $\overline{\text{EADS}}$ for an inquire cycle in clock 3, then the processor will not sample $\overline{\text{EADS}}$ asserted. (No address bus contention occurs in this case.)

- If the system logic asserts $\overline{\text{BOFF}}$ for a duration of one clock, anticipates the assertion of HLDA in clock 3, and drives the address bus and $\overline{\text{EADS}}$ for an inquire cycle in clock 4, then address bus contention may occur in clock 4. (The processor will sample $\overline{\text{EADS}}$ asserted in this case.)

If the processor does not sample $\overline{\text{EADS}}$ asserted during an inquire cycle, cache/memory incoherency will occur. Address bus contention can affect the reliability of the processor and the system logic.

Suggested Workaround. The system logic must sample the assertion of HLDA before asserting $\overline{\text{EADS}}$ and driving the address bus for an inquire cycle—as shown in clock 5 of Figure 1.

Resolution Status. AMD has determined that all Socket7 and Super7[™] chipsets operate as described in the aforementioned suggested workaround. Therefore, AMD has decided to defer the resolution of this erratum until deemed necessary.
