# Pentium® Processor Specification Update

Release Date: October, 1996

Order Number: 242480-022

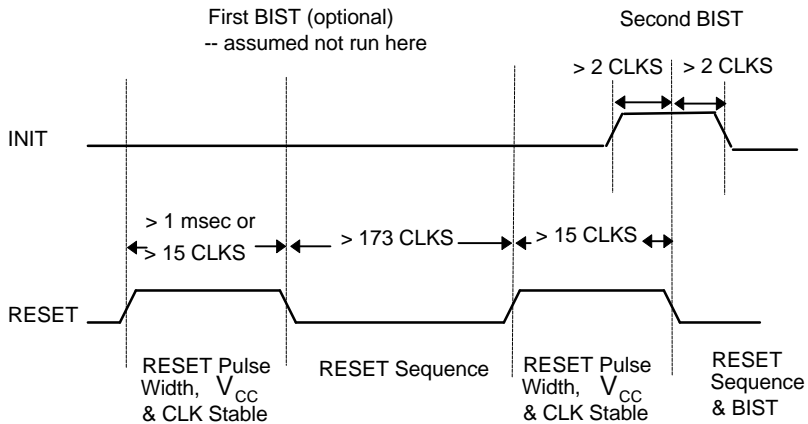
## 21. *Power-Up BIST Failure*

The first RESET pulse is used to ensure that all logic used in the BIST test is correctly initialized; optionally, INIT may be driven high to enter BIST at the falling edge of the first RESET. In this case the results of the first BIST should be ignored.

After deassertion of the first RESET pulse, a minimum of 173 clocks must elapse before assertion of the second RESET. (Note that if BIST was entered at the end of the first RESET, this 173-clock requirement is satisfied by the time required to complete the first BIST.) During the second RESET, INIT is toggled high in order to run the 'real' BIST. This BIST correctly returns results in EAX.

1. Invoke a double RESET — All false BIST failures have occurred during cold RESET. In order to accurately execute BIST, a double RESET sequence may be performed as shown in the figure below:

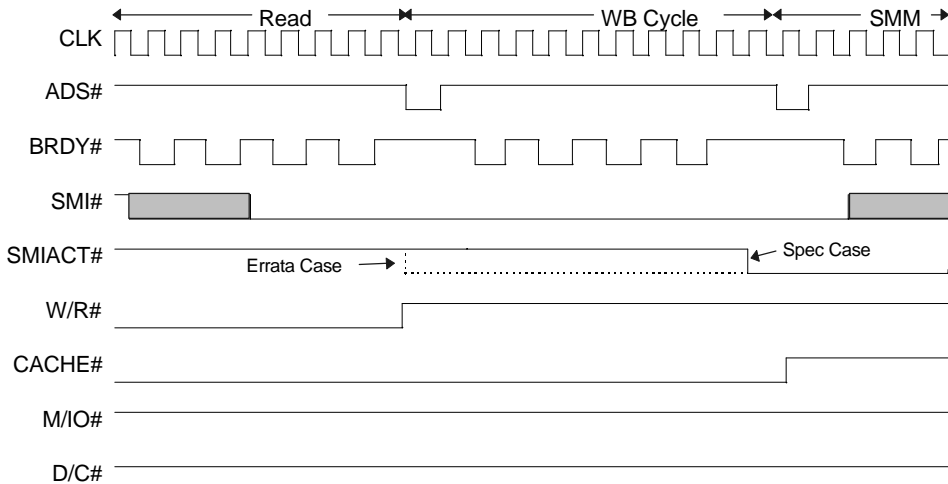
Before the processor asserts SMIACT# in response to an SMI# request, it should complete all pending write cycles (including emptying the write buffers). However, if the appropriate conditions occur, the SMIACT# signal may get asserted during the replacement writeback cycle, at anytime during the writeback cycle. See below diagram.

**IMPLICATION:** If the SMIACT# signal is used by the system logic to decode SMRAM (e.g., SMRAM is located in an area that is overlaid on top of normal memory space, e.g. system, video etc.), then the replacement writeback cycle with SMIACT# asserted could occur to SMM space. Systems that locate SMRAM in its own distinct memory space (non-overlaid) should not experience data corruption once the SMRAM has been initialized and relocated.

Some board designs and/or chip sets may contain logic which locks when an SMIACT# is asserted during the writeback cycle. This is logic dependent and not all systems will fail when this condition occurs, although data corruption could still result.

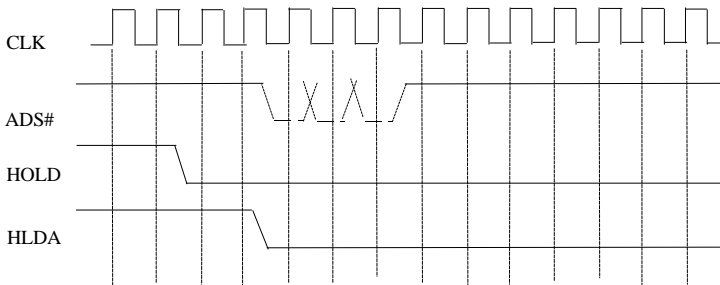
Pending Cycle May Be Delayed

**IMPLICATION:** If the system expects a cycle, for example a writeback cycle, and depends on this cycle to commence within the HLDA deassertion window, then the system may not complete the handshake and cause a hang.

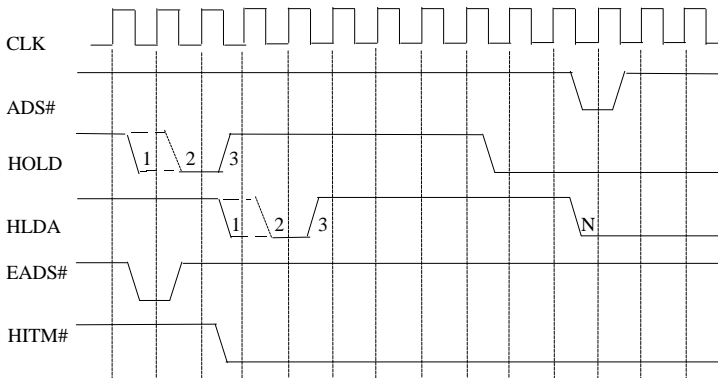
Snoop Writeback Cycle Delayed

In two cases, for example, if HOLD is deasserted for one clock (i.e., clock 2) or two clocks (i.e., clocks 1 & 2) and then reasserted, the window may not be large enough to start a pending snoop writeback cycle. The writeback cycle may be delayed until the HLDA is deasserted again (i.e., clock N). See diagram below.

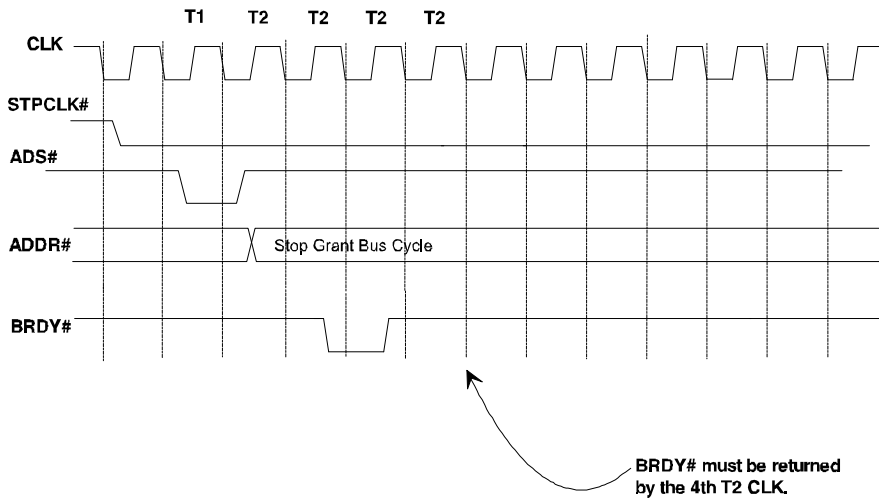
**IMPLICATION:** This problem occurs only in dual processor systems and will cause one of the processors to hang.

1. Do not assert STPCLK#.
2. Ensure that BRDY# is asserted within 4 CLKs after the Stop Grant bus cycle has begun.

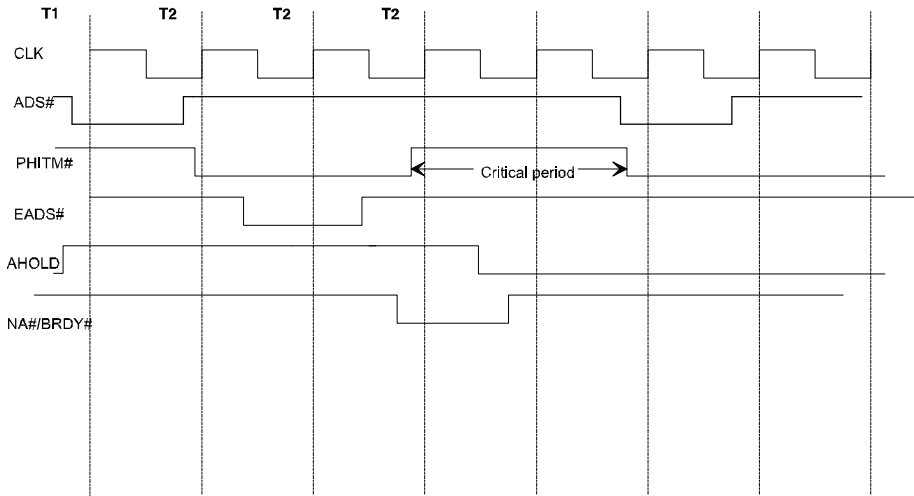
6. After the memory-write cycle is complete, the LRM performs its writeback.
7. The MRM then re-issues the memory write-cycle again. This cycle, now being issued for the third time, causes an internal hangup in the MRM.

**IMPLICATION:** If a memory write or memory read cycle is pending on the bus and an external snoop occurs, one of the processors may hang.

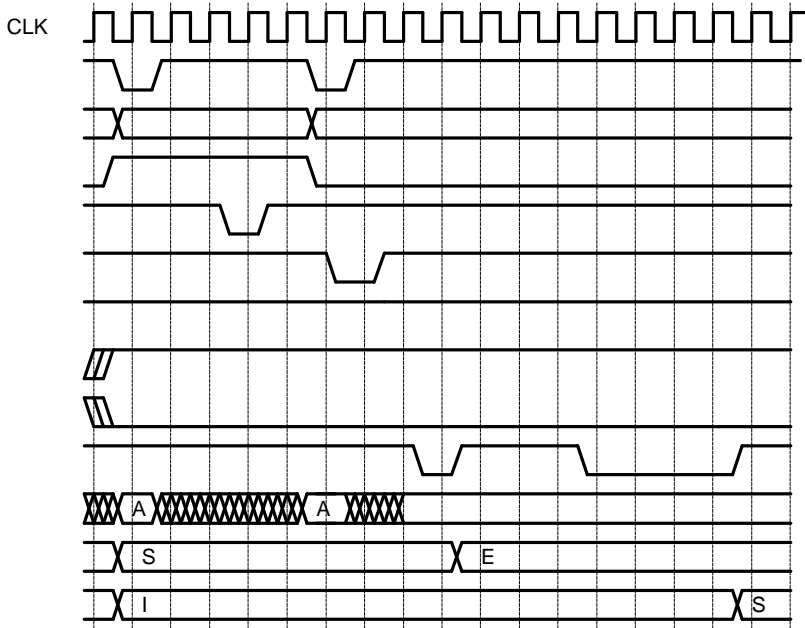
line state is (S) which will generate the PHIT#, and no PHITM#, the transition to the (E) state has been posted but is not performed until the BRDY# of the WRITE cycle.

**IMPLICATION:** If the described conditions are met, then an additional write to the same address in processor 1 will cause a cache state transition from (E) to (M) and will not generate a bus cycle. This will mean that the data in processor 2 is stale but it could continue operating with the stale data. For example: When 2 processors are sharing a cached semaphore, and processor 1 is updating the semaphore just as processor 2 is reading the semaphore, then processor 2 would eventually end up with stale data in its cache. Due to the nature of the problem, this could cause a number of unknown system problems and may or may not cause a system to hang.

**WORKAROUND:** Disable pipelining while using dual processing, this is done by not asserting NA#.

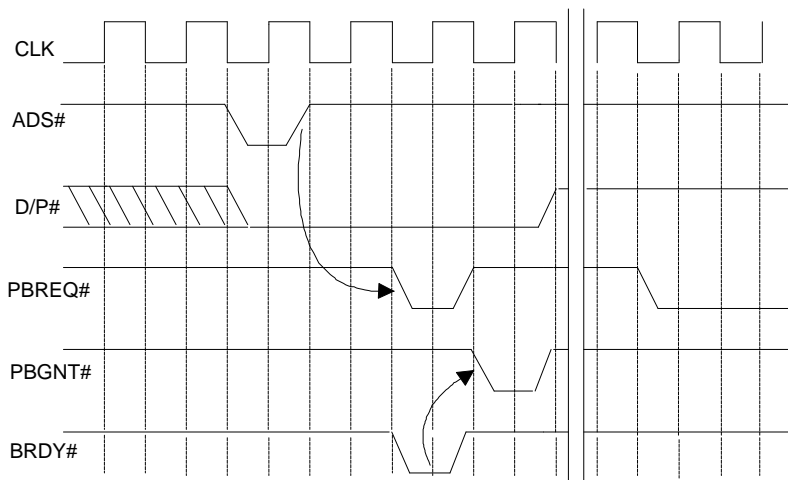
7. CPU A asserts PBREQ# to CPU B in order to obtain bus ownership back to run its pending cycle.
8. CPU B, however does not grant the bus back to CPU A since it needs to run a bus cycle before relinquishing the bus ownership. Since interrupts are disabled and the processor is executing in a tight 'spin' loop, it does not have any bus cycles to run and does not relinquish the bus.

**IMPLICATION:** A system lockup can occur because one CPU requests the bus, while the other CPU does not relinquish bus control. Running Windows NT operating system, it has been observed that when the hang condition occurs, the code inside the Windows NT kernel is always inside a very tight code loop, with at least

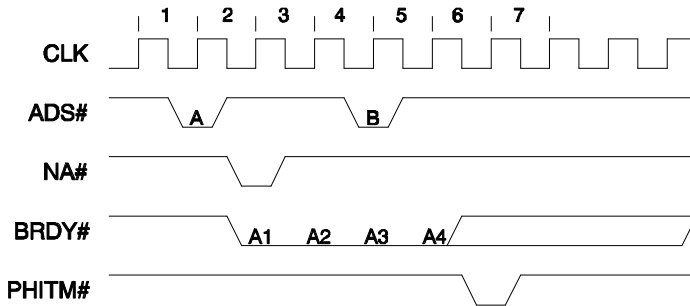
**CASE 1:**

- The processor issues read cycle A which may be pipelined into an earlier (not shown) cycle.
- Cycle A will be completed by the system as a 2-1-1-1 (zero wait state) cycle.
- One clock after issuance of the ADS#, NA# is asserted by the system.
- A pipelined cycle (B) is asserted by the MRM in clock 4.
- Cycle A completes on the bus in clock 5.
- One clock later, PHITM# is issued by the LRM.

Specifically given the above conditions, the error condition occurs internally in the CPU due to the assertion of PHITM# or BOFF# one clock after the final BRDY# of cycle A. If this occurs, the CPU will respond to the PHITM# or BOFF# by subsequently re-issuing both cycles A and B, where expected operation would be that only cycle B is re-issued.

**IMPLICATION:** The code fetch or data read cycle (A) will be re-issued even though it is already completed. The second occurrence of the cycle, even if harmless from a system point of view, will confuse the internal state of the CPU and may cause subsequent CPU mis-operation.

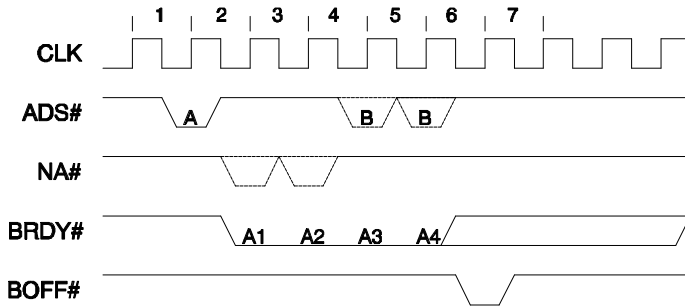
**CASE 2:**

- The processor issues read cycle A which may be pipelined into an earlier (not shown) cycle.
- Cycle A will be completed by the system as a 2-1-1-1 (zero wait state) cycle.
- One or two clocks after issuance of the ADS#, NA# is asserted by the system.
- A pipelined cycle (B) is asserted by the MRM in either clock 4 or clock 5.
- Cycle A completes on the bus in clock 5.
- One clock later, BOFF# is issued by the system.

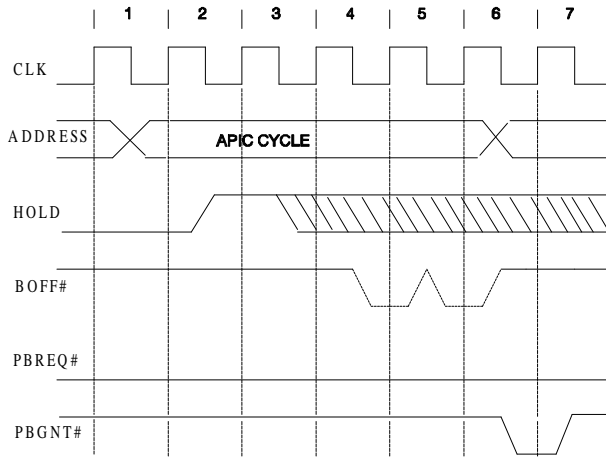
1. One of the CPUs initiates an internal APIC cycle (read or write). The LRM CPU requests ownership of the bus by asserting PBREQ#
2. HOLD is asserted during the APIC cycle
3. BOFF# is asserted before the APIC cycle gets completed, two or three clocks after HOLD is asserted (as shown in figure below)
4. Once BOFF# is deasserted, both processors may assume ownership of the bus at the same time resulting in possible contention of the CPU pins.

**IMPLICATION:** This problem affects dual processing (with CPU local APIC enabled) that assert HOLD and BOFF#. When the problem occurs, the dual processing arbitration machines of both processors get out of synchronization causing both processors to park on the bus. This will result in a system hang.

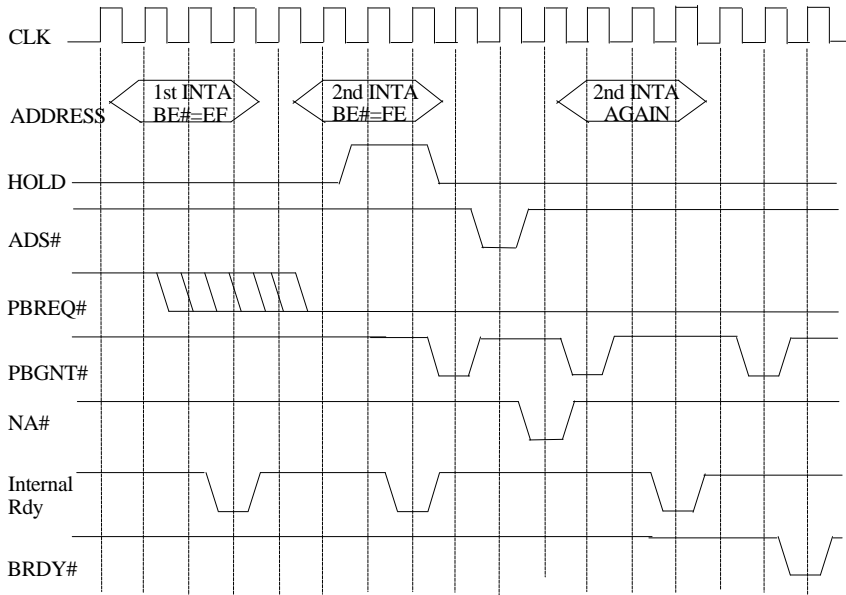
### 13DP. System Hang After Hold During Local APIC 2nd INTA Cycle

1. One of the CPU's (i.e. CPU A) initiates the first and second internal APIC INTA cycles. The INTA cycles are not driven on the external bus. CPU B requests ownership of the bus by asserting PBREQ#.
2. HOLD is asserted during the 2nd INTA cycle and PBGNT# is asserted.
3. CPU B issues a read or write cycle and receives NA# before completion of the cycle. The bus is granted back to CPU A.
4. CPU A reissues the second INTA cycle and grants the bus to CPU B.
5. CPU A hangs because the internal Rdy# and BRDY# were recognized out of order.

**IMPLICATION:** Asserting HOLD during the second INTA cycle causes the processors to lose synchronization. The external cycle completes on the bus after the INTA cycle completes which hangs the system.

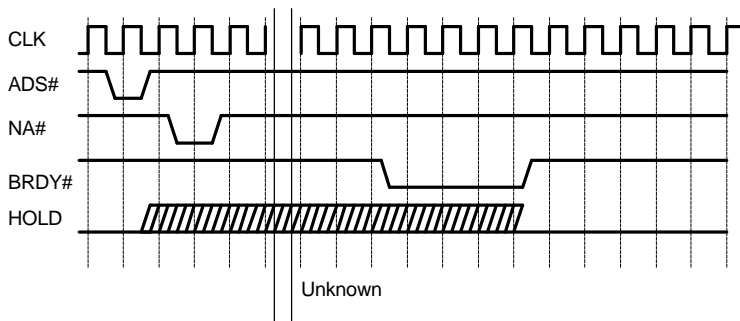
**PROBLEM:** This is an APIC related dual processor erratum: When an APIC read cycle is interprocessor pipelined into any other allowable cycle, and HOLD is prior to the last BRDY# of the outstanding cycle, the MRM processor will hang.

**IMPLICATION:** A system that uses dual processor with pipelining enabled, is subject to periodic lockups if HOLD/HLDA# protocol is used.

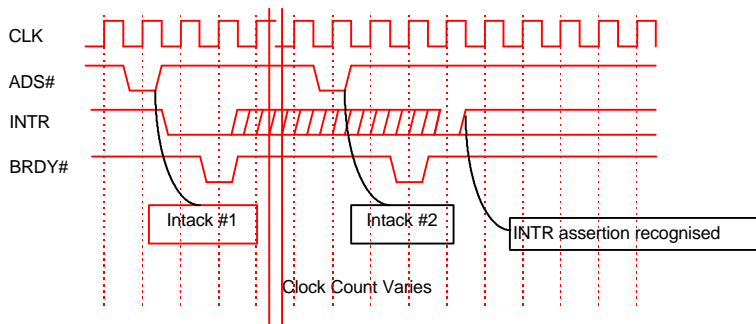
**PROBLEM:** This erratum affects APIC in through Local (virtual wire) mode. If a uniprocessing or dual processing system is using a Pentium processor with the APIC in through Local (virtual wire) mode, and the chip set is able to re-assert the INTR line prior to completion of the second Interrupt acknowledge cycle (from a prior assertion of the INTR line), then the processor will neither recognize nor service the second interrupt. The assertion edge of INTR has to occur after the completion of the second IntAck BRDY#, if there is a transition and this transition is held high during the restricted time period, this INTR will not be recognized. Software disabling of the APIC by clearing bit 8 of the SVR (spurious vector interrupt register) will not prevent this from occurring.

**IMPLICATION:** If the conditions listed above are met the system may hang up since there would be an interrupt that would not get serviced.

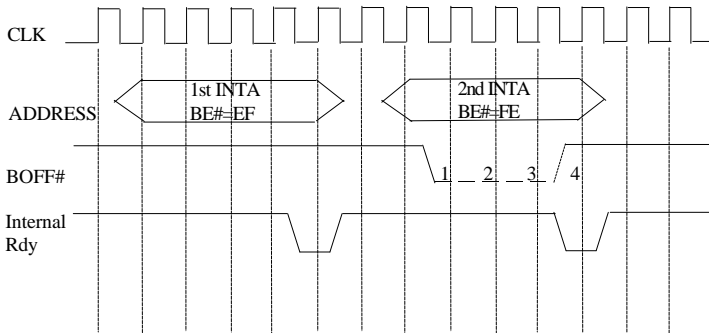
BOFF# During 2nd INTA (Non-remote Read)

**IMPLICATION:** If the system does not assert BOFF# when the processor bus is idle, then this problem will not occur. Internal APIC INTA cycles are run only when the bus is idle, thus asserting BOFF# during an external bus cycle (e.g. started by an ADS#) will avoid these circumstances. In systems that can assert BOFF# when the bus is idle, asserting BOFF# for a least 4 clocks will avoid the problem for non-remote read cases. Note that there may be other implementations that guarantee BOFF# is not asserted in the problematic window. For example, if BOFF# is only asserted with AHOLD active and AHOLD always precedes BOFF# by at least 4 clocks, the erratum is avoided.

If a remote read is occurring (e.g. between two processors) this will delay completion of the second INTA cycle by up to 8 clocks (i.e. bus clocks), and BOFF# asserted during this time may hang the system. Remote reads are typically performed during system debug and not in normal operation. Not performing remote reads will avert this case.

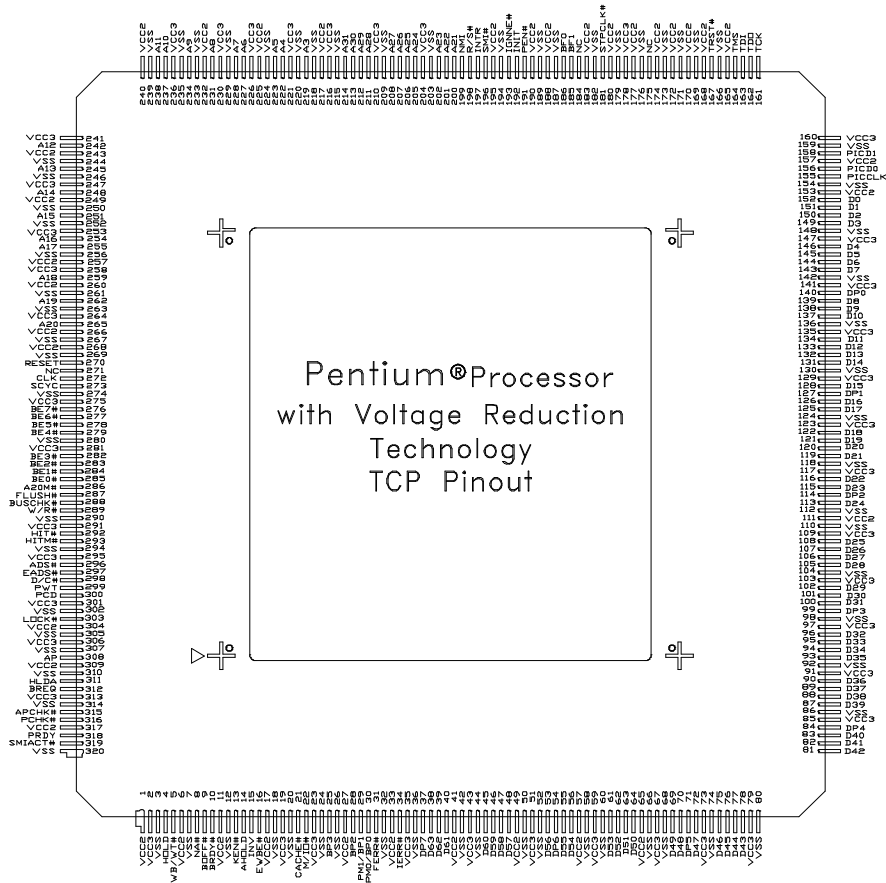
The TCP pinout drawing on page 8 of the Pentium Processor with Voltage Reduction Technology Data Sheet was inadvertently rotated. The correct orientation is shown below.
