Pentium® Processor Specification Update

Release Date: August, 1997

Order Number: 242480-029

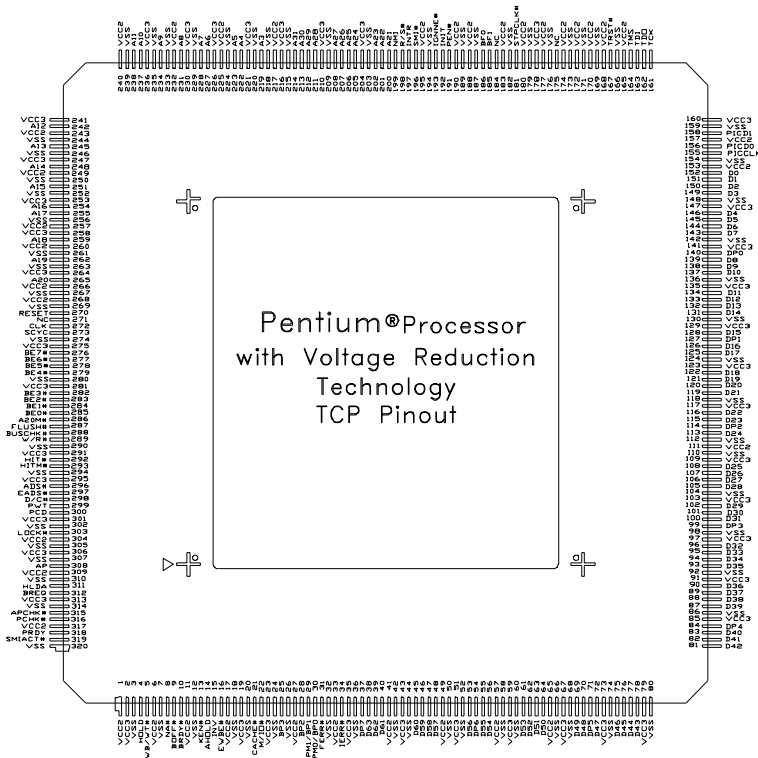
2. **Incorrect TCP Pinout Drawing**

The TCP pinout drawing on page 8 of the *Pentium Processor with Voltage Reduction Technology* datasheet was inadvertently rotated. The correct orientation is shown below.

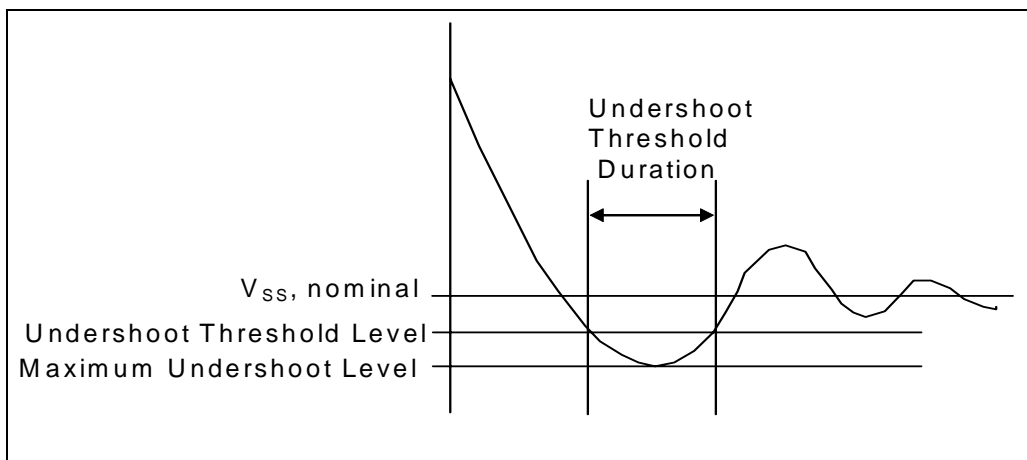
Figure14-1. Maximum Undershoot Level, Undershoot Threshold Level, and Undershoot Threshold Duration

UNDERSHOOT THRESHOLD DURATION SPECIFICATION: A snapshot of the clock signal should be taken at 500 mV/div and 500 pS/div (for CLK). Adjust the vertical position and horizontal offset position to view the threshold duration. The undershoot threshold duration is defined as the sum of all time during which the clock signal is below -0.5V within a single clock period. The undershoot threshold duration must not exceed 20% of the period.

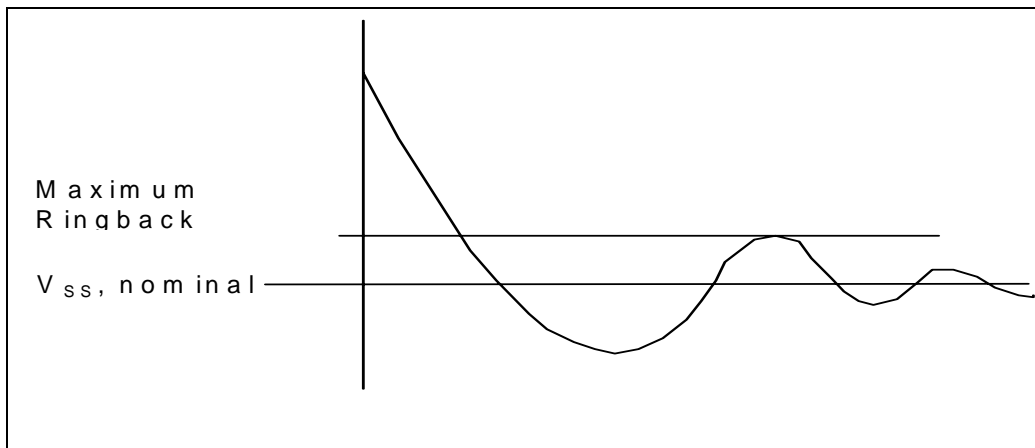
Figure 14-2. Maximum Ringback Associated with the Signal Low State

MAXIMUM UNDERSHOOT AND MAXIMUM RINGBACK SPECIFICATIONS: The display should show continuous sampling (e.g., infinite persistence) of the waveform at 500 mV/div and 5 ns/div (for CLK) for a recommended duration of approximately five seconds. Adjust the vertical position to measure the maximum undershoot and associated ringback. There is no allowance for crossing the maximum undershoot or maximum ringback specifications.
