# Pentium® Processor Specification Update

Release Date: October, 1996

Order Number: 242480-022

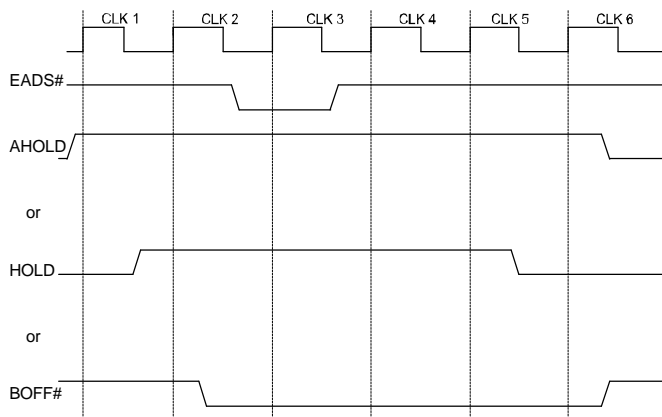
All of the listed workarounds prevent the MRM processor from starting a new cycle, thus preventing the third restart of the pending cycle.

1. Ensure that NA#/BRDY# is asserted before, or after the "critical period". (the critical period is the two CLK period after EADS# is sampled active.)  
or
2. Ensure that AHOLD is held high for a minimum of three clocks after EADS# has been sampled active. See the following figure.  
or
3. Drive HOLD for two clocks after the EADS# was sampled active. Removal of HOLD can be done without regard to the HLDA signal. See the following figure.  
or
4. Drive BOFF# for 3 clocks after the EADS# was sampled active. See the following figure.

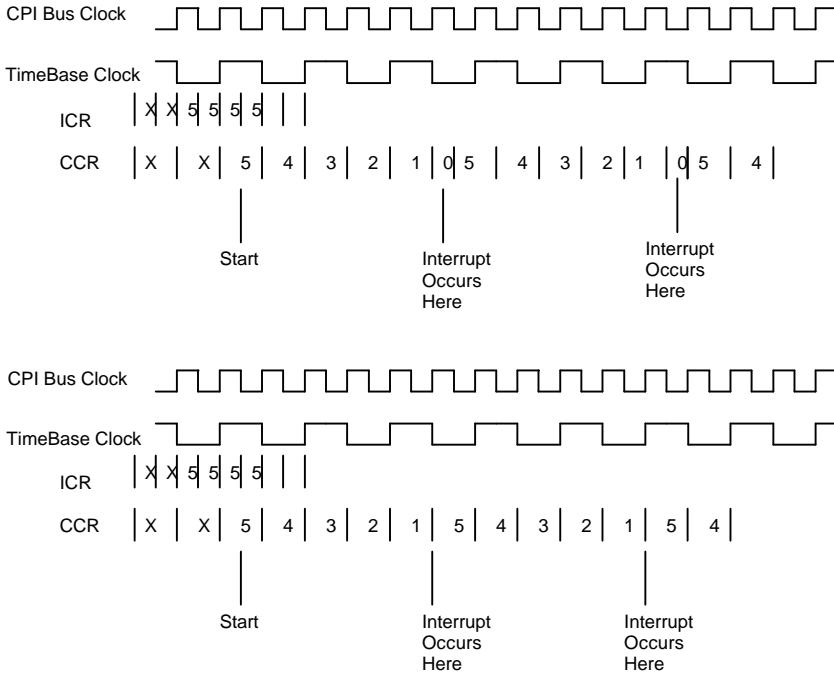
The APIC Timer functions correctly, but there is one timer "tick" that is a different pulse width than the other timer "ticks". The countdown performs correctly regardless of the divisor that is programmed, each of these ticks is of the same pulse width, but the last tick is held for just one single timer clock regardless of the divisor programmed. This results in a slightly inaccurate timer. This last tick pulse width is shown in the top diagram. The lower diagram shows how the accuracy of the timer will be corrected in a future stepping. This phenomenon occurs when the timer is used as a single shot generator as well.

NOTE: The CPU Bus clock in which the CCR is loaded from the ICR occurs one clock after the ICR is loaded.
