Pentium® Processor Specification Update

Release Date: January 1998

Order Number: 242480-034

The Pentium® processor may contain design defects or errors known as errata which may cause the product to deviate from published specifications. Current characterized errata are documented in this Specification Update.

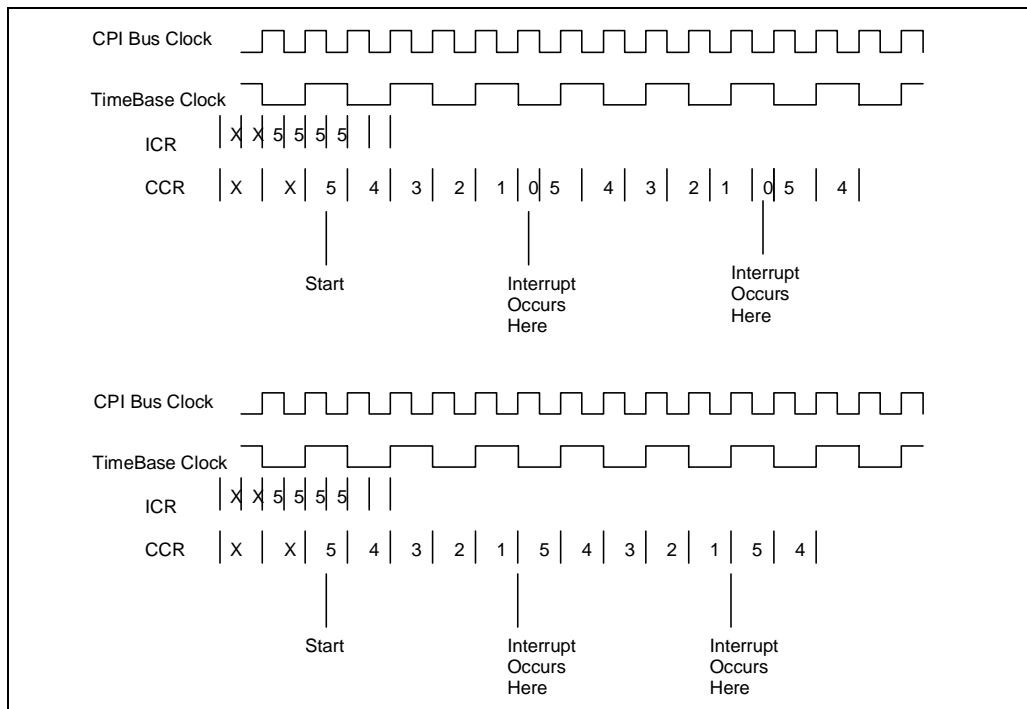
NOTE:

The CPU Bus clock in which the CCR is loaded from the ICR occurs one clock after the ICR is loaded.

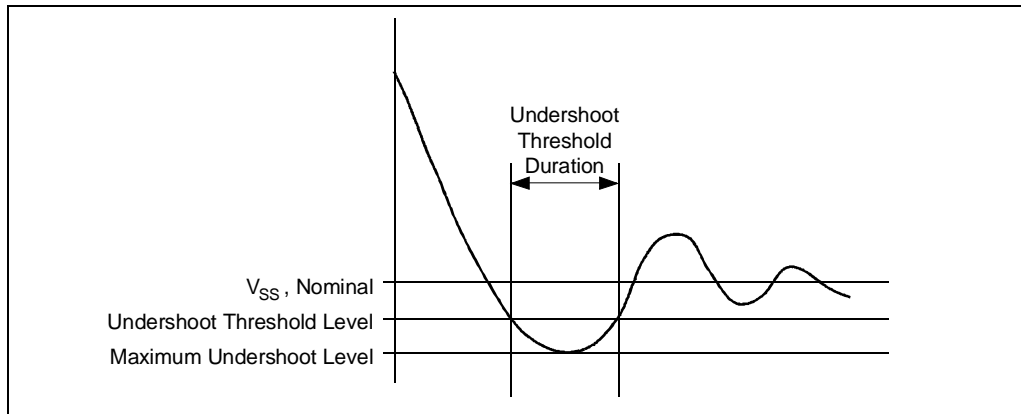
UNDERSHOOT THRESHOLD DURATION SPECIFICATION: A snapshot of the clock signal should be taken at 500 mV/div and 500 pS/div (for CLK). Adjust the vertical position and horizontal offset position to view the threshold duration. The undershoot threshold duration is defined as the sum of all time during which the clock signal is below -0.5V within a single clock period. The undershoot threshold duration must not exceed 20% of the period.

Figure14-1. Maximum Undershoot Level, Undershoot Threshold Level, and Undershoot Threshold Duration

1. See Figure 14-1 and Figure 14-2.

This undershoot specifications are illustrated graphically in Figure 14-1 and Figure 14-2.
